SERVICE NO. 1273A BULLETIN

Date: October 22, 2015

**BULKHEAD MODIFICATION AT FUSELAGE
STATION 317.75**

PA-31/PA-31-300/325 Navajo
PA-31-350 Chieftain/T-1020

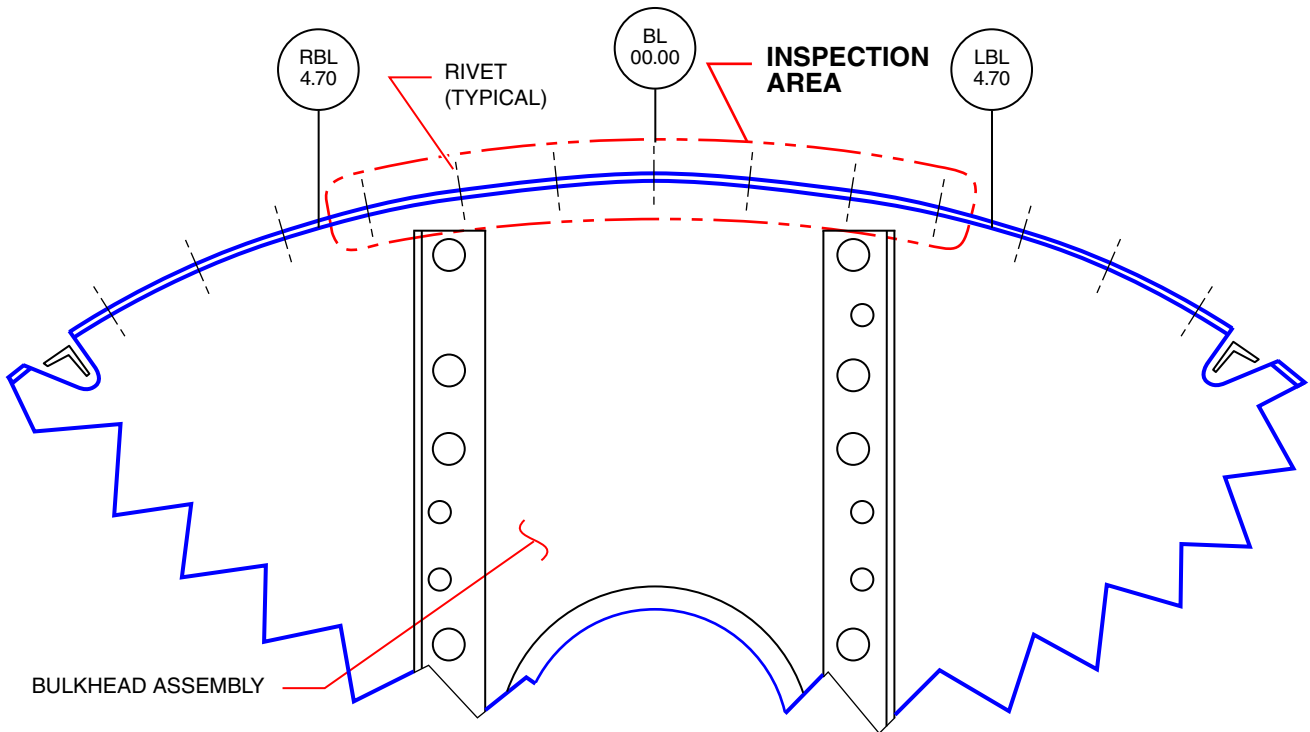
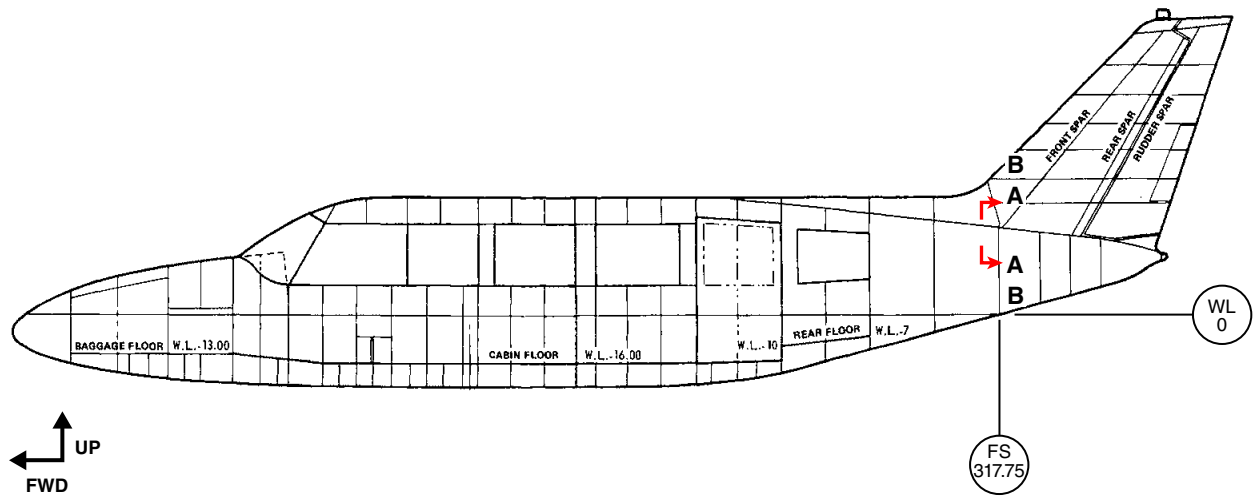
Figure 1, Sheet 1
Aft Fuselage Inspection Area

1. RC – Gain visual access to the bulkhead assembly at FS 317.75, as shown in Figure 1, Sheet 1.
2. RC – Inspect
 - a. Prior to inspection, wipe surfaces clean using a soft cloth dampened with isopropyl alcohol, mineral spirits, naphtha, or other suitable cleaning agent or method.
 - b. Examine the area shown in View A–A labeled “INSPECTION AREA” for cracks. The inspection shall be accomplished using a 10X magnifier, a mirror and a suitable light source or other equipment capable of providing equal or better resolution.
3. RC – Assess inspection results
 - a. If a crack is found, follow repair instructions described in Piper Kit P/N 764-028 Rev. 10/26/2015, “Bulkhead Reinforcement and Drag Angle Installation.” Repairs must be accomplished prior to next flight.

LOOKING AFT AT FS 317.75
INSPECTION AREA
