SERVICE NO. 1273A BULLETIN

Date: October 22, 2015

**BULKHEAD MODIFICATION AT FUSELAGE
STATION 317.75**

PA-31/PA-31-300/325 Navajo
PA-31-350 Chieftain/T-1020

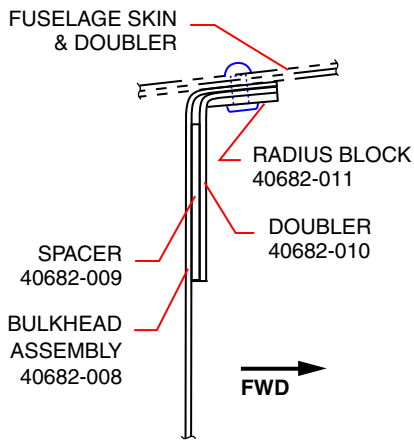
CONFIGURATION 1

Incorporating this service bulletin results in installing a doubler and supporting structure on the forward upper surface of the bulkhead assembly located at FS 317.75. Depending on the existing configuration of the aircraft, this doubler may replace a smaller doubler at the same location. For some aircraft, the required doubler may already be installed. For these aircraft, no airframe modification is required.
